Analysis of SOS Results for Engine Lubricants Contaminated by the Fuel in The 3516 TA Diesel Engine Generator Set

Wilarso^{1*}, Aswin Domodite¹, Hilman Sholih¹ and Mujiarto²

Abstract. Generator Set Unit that operates in the PLTD, during operation there is a knocking sound at cylinder position # 14, after checking and removing the injector there is diesel in the combustion chamber and indicated glowing in the exhaust manifold. The purpose of this study is to determine the root causes of knocking and diesel fuel in the combustion chamber. This research method uses oil sample testing to be tested in the laboratory. The results of the analysis of oil contaminated with diesel fuel are caused by diesel oil flowing into the pan oil and after checking the cylinder head crack (groove-shaped) is found on the side of the injector seal holder, when the unit is not operating the diesel flows into the combustion chamber and into the oil reservoir. The groove in the cylinder head is formed, caused by a hard injector seal caused by fuel temperature and high water temperature. The solution of this research is that the pressure on the fuel return from the engine should not exceed 27 kPa, while the

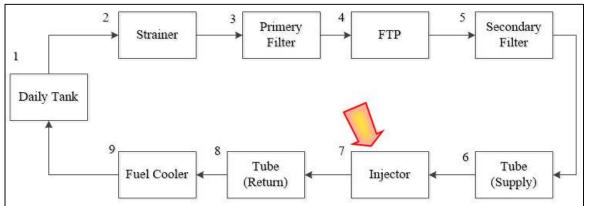
In the explanation in Figure 1, 1) Daily tank functions to collect fuel after leaving the engine, 2) the strainer functions to filter large particles before entering the fuel system. 3) Primary filter functions to filter small particles in micron size, 4) Fuel transfer pump to transfer to the fuel system, 5) Secondary filter functions to filter particles under 5 microns, 6) tube (supply) to deliver fuel to the injector, 7) The injector functions to inject fuel into the fuel chamber, 8) Tube (return) distributes the material after the injector, 9) The fuel cooler functions to cool the fuel after the injection system, the damage that occurs at no. 7 (injector).

Figure 1. Position of damage to the injector

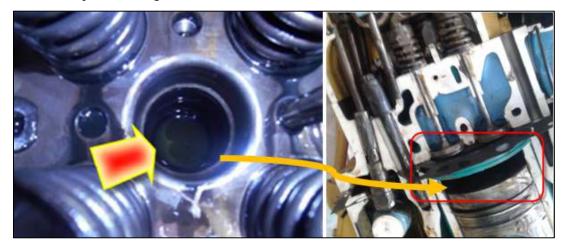
Based on the cylinder head inspection it was found that the diesel fluid was in the combustion chamber, which is explained in figure 2.

Figure 2. Solar is in the combustion chamber.

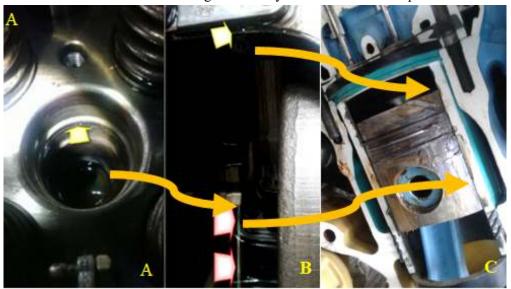
The formation of a groove injector seal holder in the cylinder head resulting in leakage of fuel into the combustion chamber and diesel fuel flowing from the cylinder head to the oil pan.

Figure 3. The formation of the groove on the cylinder head in the injector seal holder.

Engine lubricant mixed with diesel fuel results in reduced lubricant viscosity (fuel dilution) caused by damage to the hardened injector seal, with hardening of the injector seal friction, which occurs with the seal holder and shaped groove. When the unit is operating, the fuel will flow into the combustion

chamber, causing abnormalities in the combustion process and when the unit is not operating, diesel will flow into the combustion chamber and then flow the oil pan. This is affected by the high fuel temperature, damaging the injector seal holder in the cylinder head and not fitting the holder. Groove on the cylinder head wall a maximum of 2 millimeters in-depth, if it exceeds 2 milli it will cause fatality to other engine components. To prevent fuel dilution from occurring, care must be taken regarding the temperature of the fuel. treatment, preventing fuel temperatures from rising beyond 60 °C (150 °F). Preventing back pressure fuel return exceeds the maximum limit of 27 kPa (kilopascal) and performs maintenance by procedures, as well as routine engine lubricant testing, to find out the diesel content of the engine lubricant.

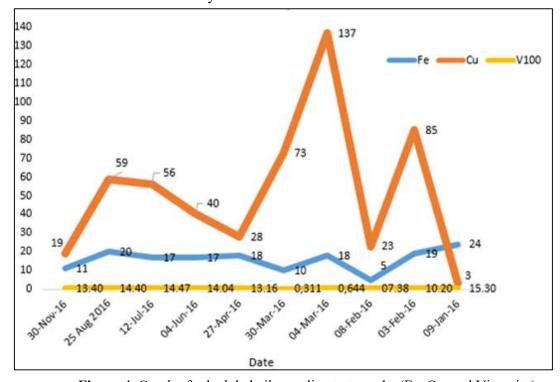
Increased wear element Cu is found in bearing material, bushings, friction in engine components that come in contact with metal components with metals, causing wear on bearing or bushing elements. As for engine lubricant that is contaminated with diesel fuel causes thinning of the oil film, according to the data in figure 4, where on March 4 and March 30 2016 oil viscosity was recorded at 0.311 and 0.644, the condition of the lubricant being low viscosity. The rate of wear from January to November 2016, wear element Fe, Cu trending is quite high starting from January and followed by a decrease in viscosity from January to March 2016. After March 2016 has been done to repair damaged components so that the lubricant viscosity becomes stable.

Figure 4. Graph of scheduled oil sampling test results (Fe, Cu, and Viscosity)

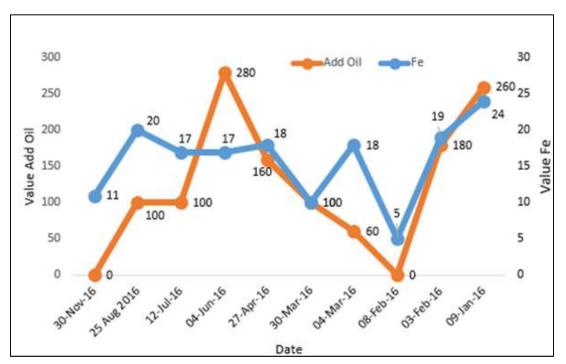
In the explanation of figure 5 the increase in Fe is balanced by the addition of lubricant at each lubricant change interval at 500 hours [9], enough to increase and including the addition of oil up to 260 liters on January 9, 2016, and 280 liters on June 04, 2016. With the Fe trend, increasing wear occurs in the liner wall. The impact on shiny on the inner liner wall described in Figure 6 [10] [11], lubricant also burns during the process of movement of the piston from BDC to TDC and the combustion process in the [12] combustion chamber occurs [13] and causes the lubricant to decrease, this will result in engine components will be damaged quickly, including bearings, shafts [14].

Figure 5. Graph of scheduled oil sampling testing (Fe vs Add Oil Lubricant).
