Analysis of SOS Results for Engine Lubricants Contaminated by the Fuel in The 3516 TA Diesel Engine Generator Set

Wilurso(1), Aswin Domodite(1), Hilman Sholih (1), Mujiarto (2)

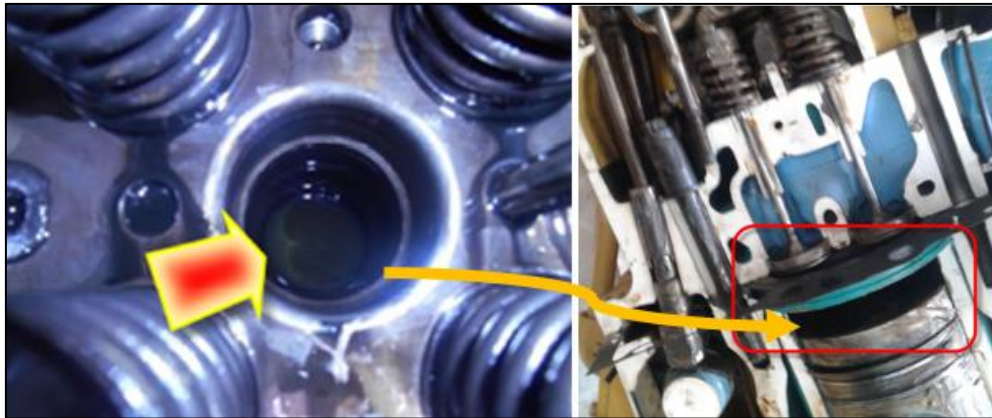
Based on the cylinder head inspection it was found that the diesel fluid was in the combustion chamber, which is explained in figure 2.

Figure 2. Diesel is in the combustion chamber.

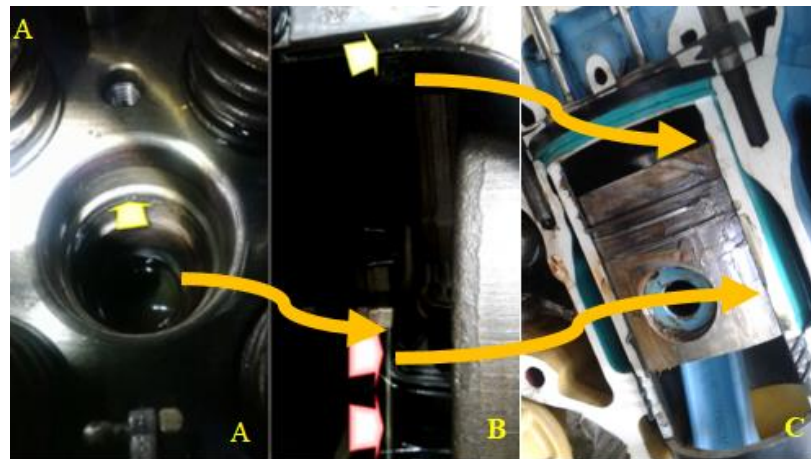
The formation of a groove in the injector seal holder in the cylinder head resulting in leakage of fuel into the combustion chamber and diesel fuel flowing from the cylinder head to the oil pan.

Figure 3. The formation of the groove on the cylinder head in the injector seal holder.

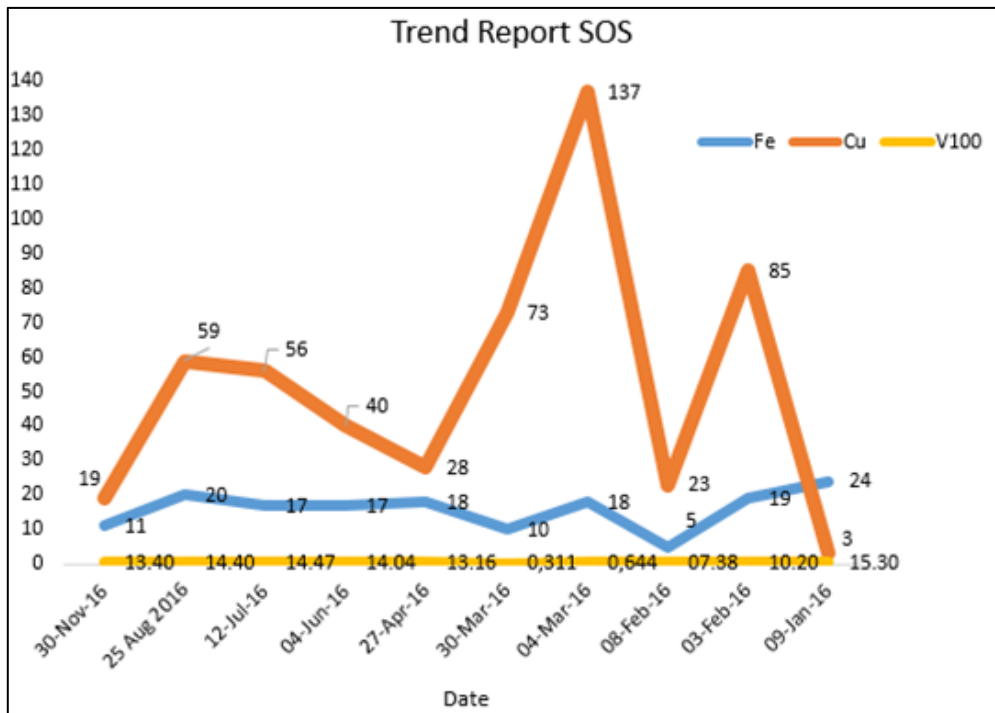
Increased wear element Cu is found in bearing material, bushings, friction in engine components that come in contact with metal components with metals, causing wear on bearing or bushing elements. As for engine lubricant that is contaminated with diesel fuel causes thinning of the oil film, according to the data in figure 4, where on March 4 and March 30 2016 oil viscosity was recorded at 0.311 and 0.644, the condition of the lubricant being low viscosity. The rate of wear from January to November 2016, wear element Fe, Cu trending is quite high starting from January and followed by a decrease in viscosity from January to March 2016.

After March 2016 has been done to repair damaged components, so that the lubricant viscosity becomes stable.

Figure 4. Graph of schedule oil sampling test results (Fe, Cu, and Viscosity)

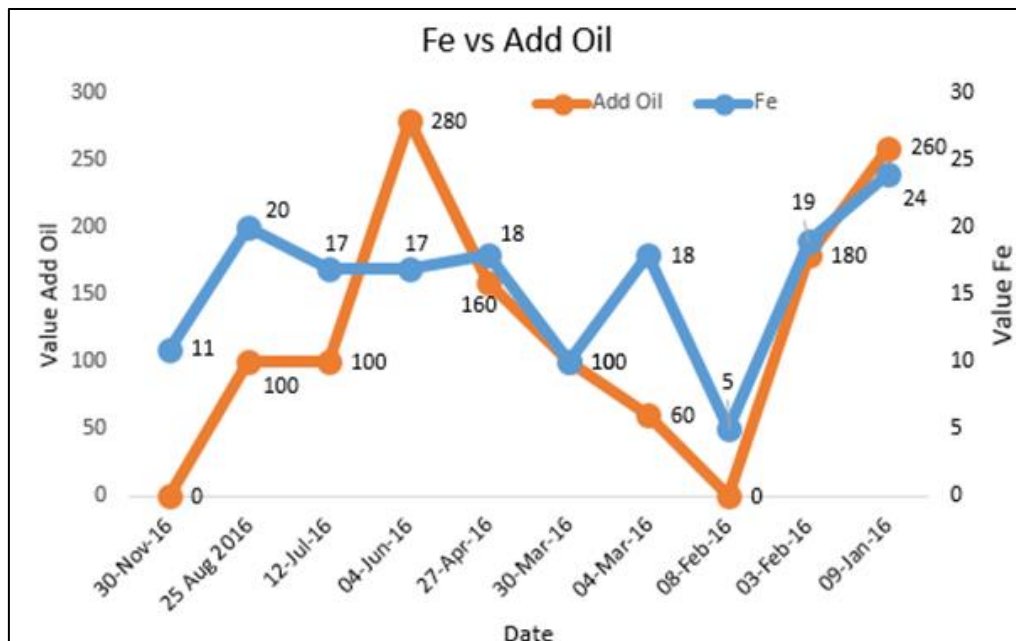
In the explanation of figure 5 the increase in Fe is balanced by the addition of lubricant at each lubricant change interval at 500 hours [10], enough to increase and including the addition of oil up to 260 liters on January 9, 2016, and 280 liters on June 04, 2016. With the Fe trend, increasing wear occurs in the liner wall. The impact on shiny on the inner liner wall described in Figure 6 [11] [12], lubricant also burns during the process of movement of the piston from TMB to TDC and the combustion process in the combustion chamber occurs and causes the lubricant to decrease.

Figure 5. Graph of schedule oil sampling testing (Fe vs Add Oil Lubricant).

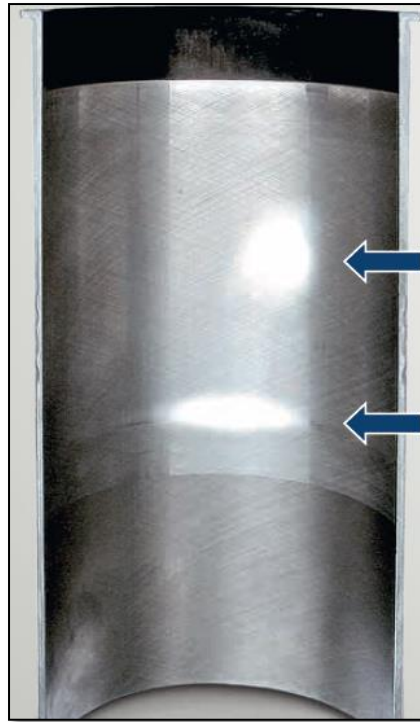
Figure 6. Shiny at liner [10].

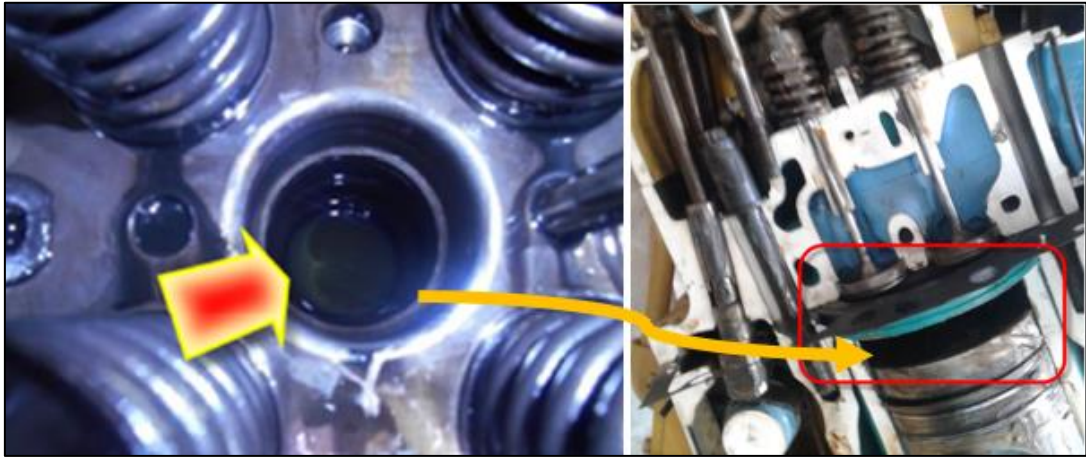
Based on the cylinder head inspection it was found that the diesel fluid was in the combustion chamber, which is explained in figure 2.

Figure 2. Solar is in the combustion chamber.

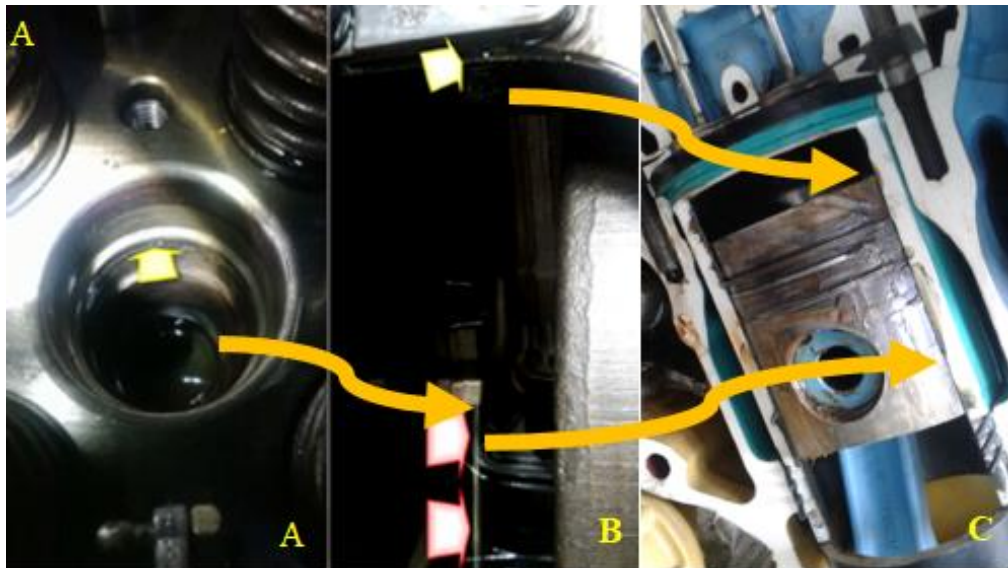
The formation of a groove injector seal holder in the cylinder head resulting in leakage of fuel into the combustion chamber and diesel fuel flowing from the cylinder head to the oil pan.

Figure 3. The formation of the groove on the cylinder head in the injector seal holder.

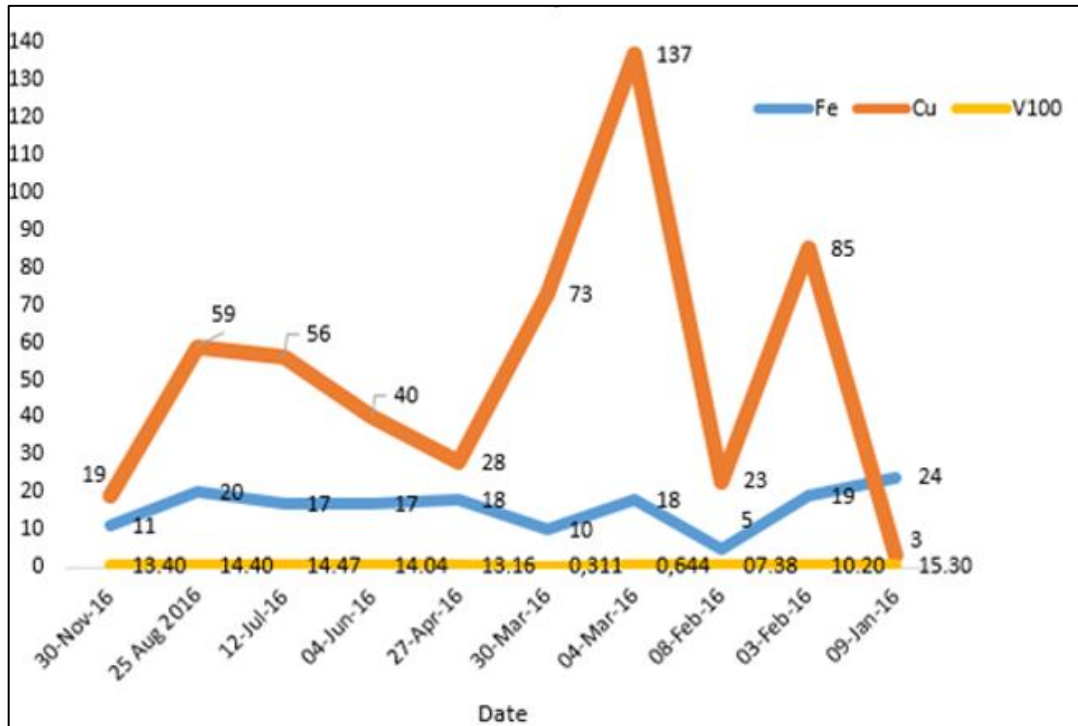
Increased wear element Cu is found in bearing material, bushings, friction in engine components that come in contact with metal components with metals, causing wear on bearing or bushing elements. As for engine lubricant that is contaminated with diesel fuel causes thinning of the oil film, according to the data in figure 4, where on March 4 and March 30 2016 oil viscosity was recorded at 0.311 and 0.644, the condition of the lubricant being low viscosity. The rate of wear from January to November 2016, wear element Fe, Cu trending is quite high starting from January and followed by a decrease in viscosity from January to March 2016. After March 2016 has been done to repair damaged components so that the lubricant viscosity becomes stable.

Figure 4. Graph of scheduled oil sampling test results (Fe, Cu, and Viscosity)

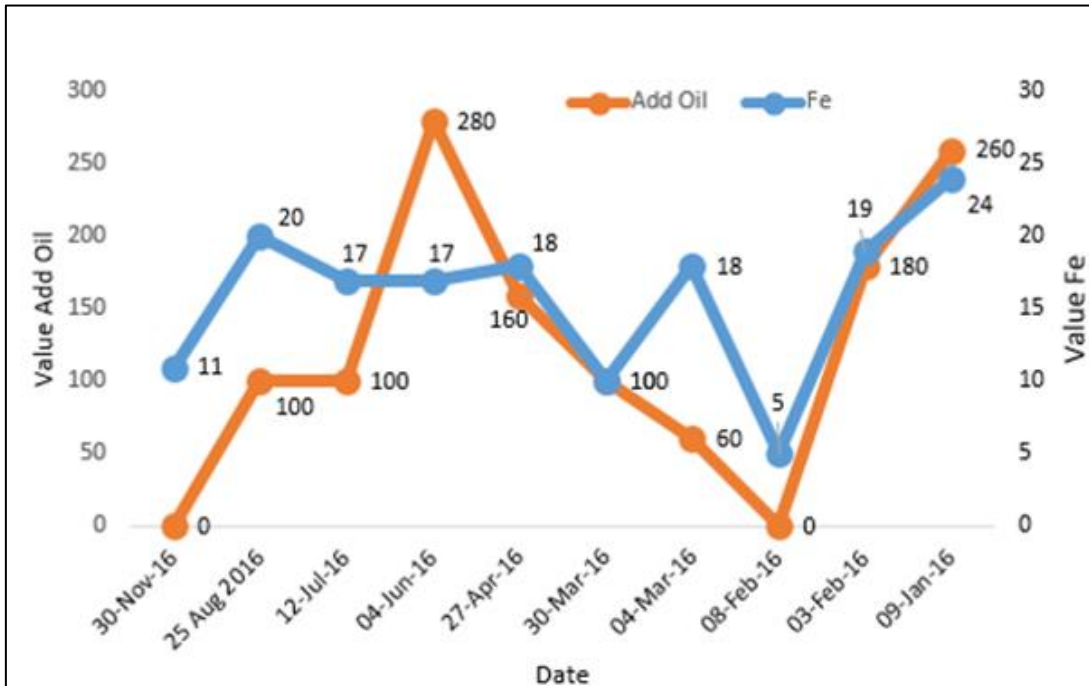
In the explanation of figure 5 the increase in Fe is balanced by the addition of lubricant at each lubricant change interval at 500 hours [9], enough to increase and including the addition of oil up to 260 liters on January 9, 2016, and 280 liters on June 04, 2016. With the Fe trend, increasing wear occurs in the liner wall. The impact on shiny on the inner liner wall described in Figure 6 [10] [11], lubricant also burns during the process of movement of the piston from BDC to TDC and the combustion process in the [12] combustion chamber occurs [13] and causes the lubricant to decrease, this will result in engine components will be damaged quickly, including bearings, shafts [14].

Figure 5. Graph of scheduled oil sampling testing (Fe vs Add Oil Lubricant).

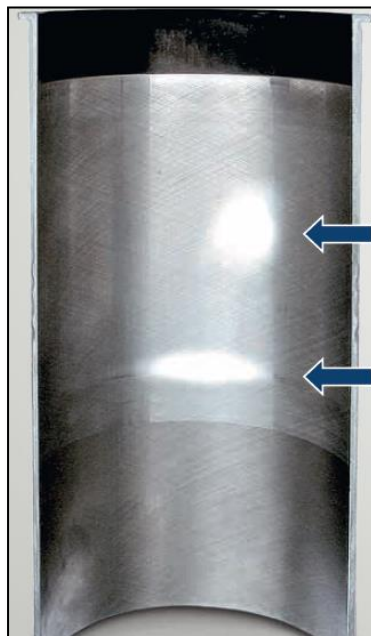
Figure 6 explains the occurrence of shiny in the liner where there is friction between the piston ring and the liner wall in the shiny region of the surface of the liner caused by scale deposits [15] on the middle and bottom sides. Indications that occurred in oil testing indicated an increase in the Fe element.

Figure 6. Shiny at liner [9].

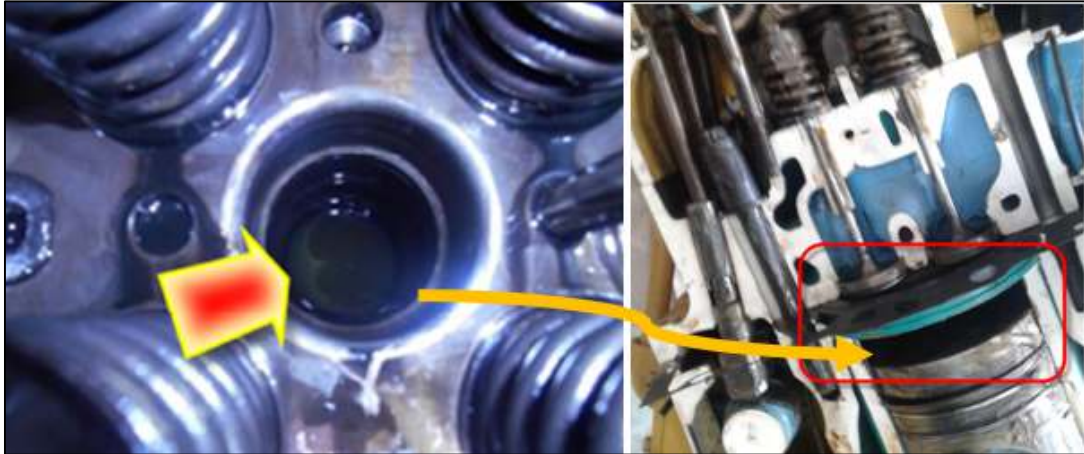
Based on the cylinder head inspection it was found that the diesel fluid was in the combustion chamber, which is explained in figure 2.

Figure 2. Solar is in the combustion chamber.

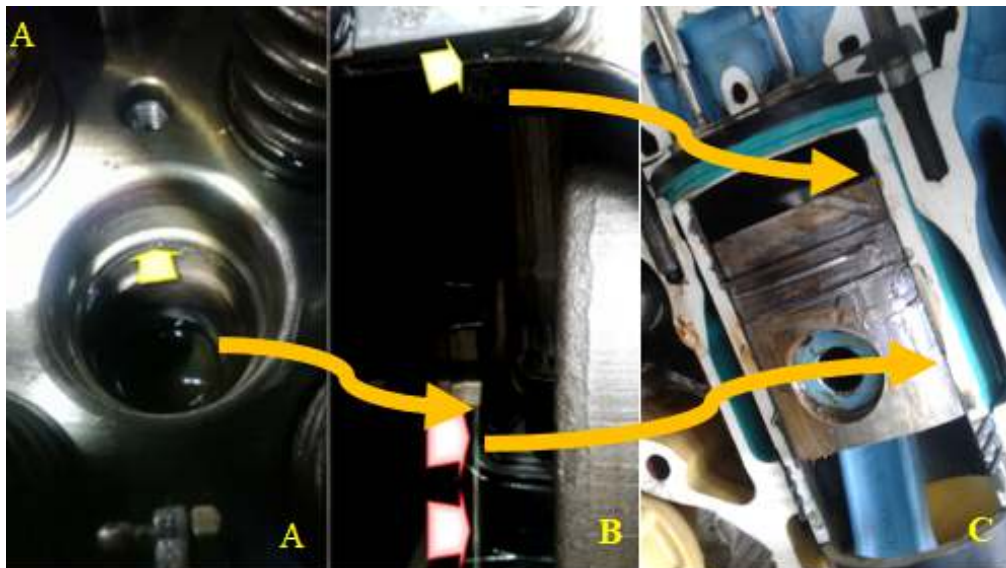
The formation of a groove injector seal holder in the cylinder head resulting in leakage of fuel into the combustion chamber and diesel fuel flowing from the cylinder head to the oil pan.

Figure 3. The formation of the groove on the cylinder head in the injector seal holder.

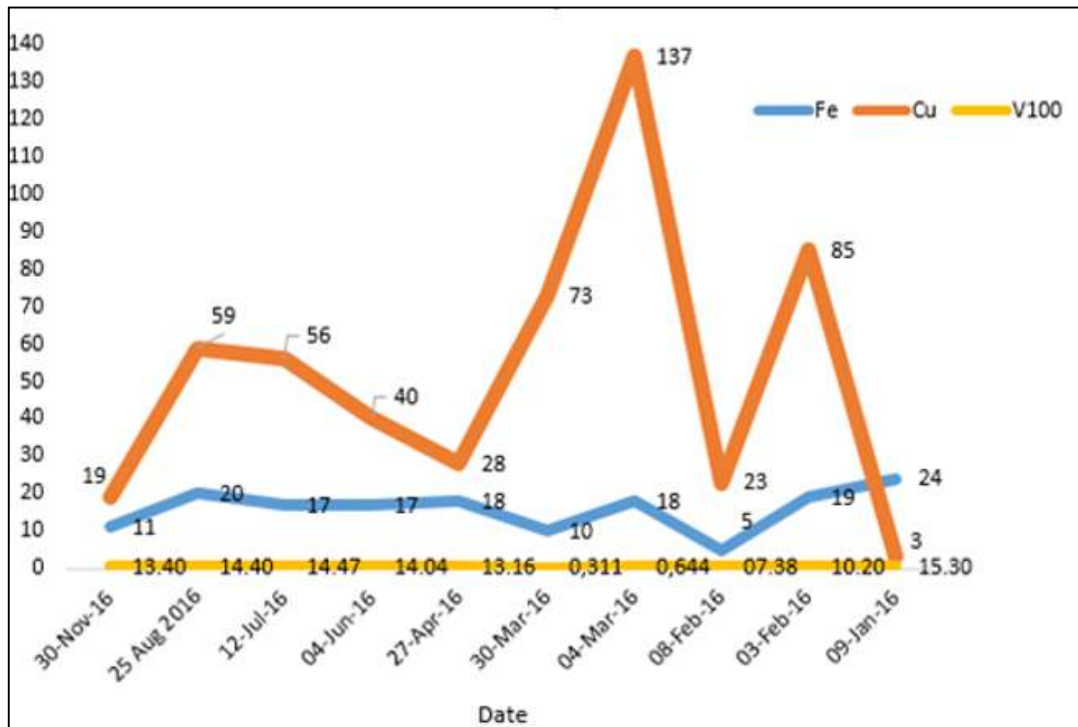
Increased wear element Cu is found in bearing material, bushings, friction in engine components that come in contact with metal components with metals, causing wear on bearing or bushing elements. As for engine lubricant that is contaminated with diesel fuel causes thinning of the oil film, according to the data in figure 4, where on March 4 and March 30 2016 oil viscosity was recorded at 0.311 and 0.644, the condition of the lubricant being low viscosity. The rate of wear from January to November 2016, wear element Fe, Cu trending is quite high starting from January and followed by a decrease in viscosity from January to March 2016. After March 2016 has been done to repair damaged components so that the lubricant viscosity becomes stable.

Figure 4. Graph of scheduled oil sampling test results (Fe, Cu, and Viscosity)

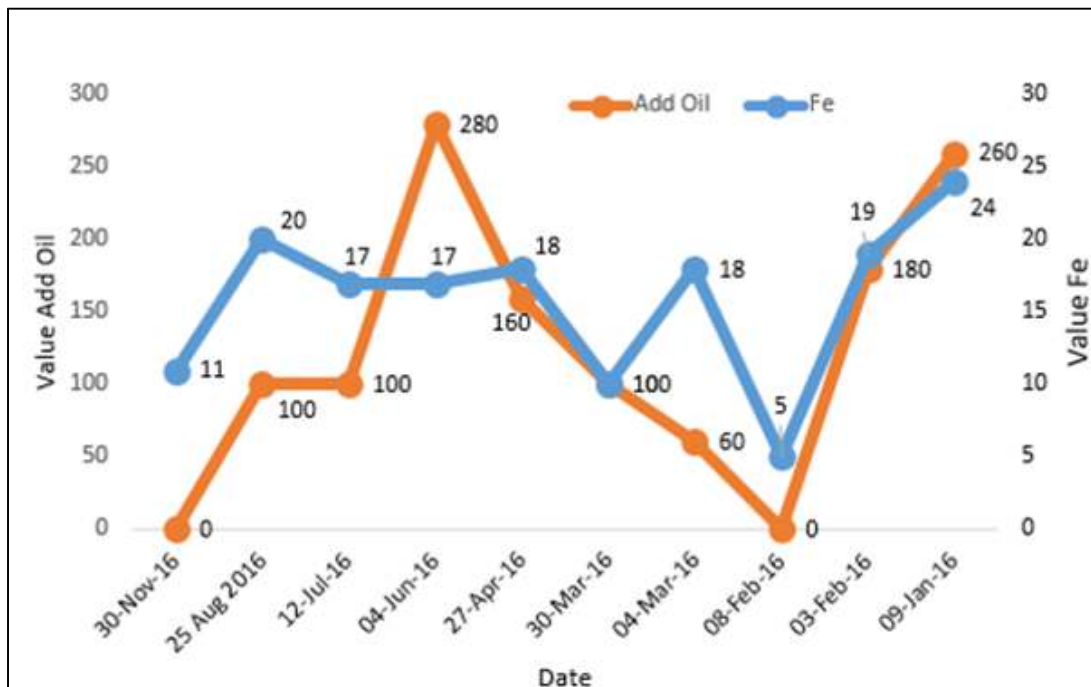
In the explanation of figure 5 the increase in Fe is balanced by the addition of lubricant at each lubricant change interval at 500 hours [9], enough to increase and including the addition of oil up to 260 liters on January 9, 2016, and 280 liters on June 04, 2016. With the Fe trend, increasing wear occurs in the liner wall. The impact on shiny on the inner liner wall described in Figure 6 [10] [11], lubricant also burns during the process of movement of the piston from BDC to TDC and the combustion process in the [12] combustion chamber occurs [13] and causes the lubricant to decrease, this will result in engine components will be damaged quickly, including bearings, shafts [14].

Figure 5. Graph of scheduled oil sampling testing (Fe vs Add Oil Lubricant).

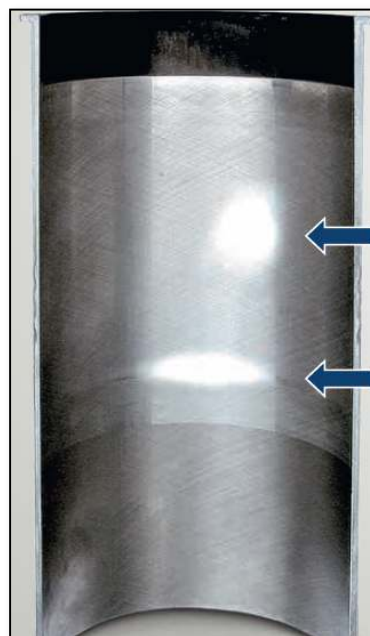
Figure 6 explains the occurrence of shiny in the liner where there is friction between the piston ring and the liner wall in the shiny region of the surface of the liner caused by scale deposits [15] on the middle and bottom sides. Indications that occurred in oil testing indicated an increase in the Fe element.

Figure 6. Shiny at liner [9].
