Analysis of injector spring damage to determine maintenance management diesel engine at PLTD Ampenan

Abstract. The injector spring in cylinder #2 of a diesel engine in Ampenan PLTD which is operated by PT. X damaged. After visual inspection, a helical spring of the injector was broken. The spring broke in the lower part, in winding 2 of the spring. Before the damage was known, with a diesel load of 1100 kW, the exhaust manifold the cylinder #2 was glowing. Root cause analysis of the broken spiral spring was carried out by visual observation, metallography, and maintenance management analysis. Results indicated that the damaged of the broken injector spring based on visual observation of the helical spring was due to alternating bending loads. The fracture angle was at 45° indicated a bending load. Benchmark shows the beginning of the fault, followed by a static fracture. Metallographic and microstructure examination results found too many sulphides possibly making the formation of the onset of the fatigue. To minimize the damage, the sulphide amount of the spring must be reduced, and the spring injector material must be redesigned. Maintenance management must check every time the

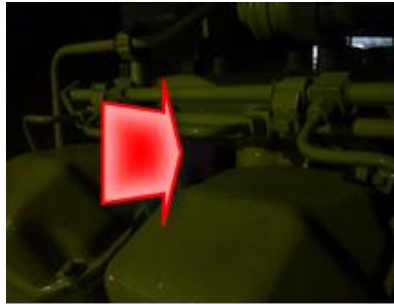
When the spiral spring of the injector breaks the pressure on the injector it drops slowly, and the duration of the fuel spraying will take longer, because the pressure inside the injector drops slowly, as a result, it will occur over fuelling and glowing. On 30 minutes prior to the red or glowing damage to the exhaust manifold and then an emergency trip (normal stop) by the operator is explained in Figure 1. Damage to the injector that causes Gen-Set to be inoperable and after checking the injector helical spring is found Broken at the bottom shown in figure 1. After checking, it was found that a broken injector spring at the bottom as shown in Figure 2.

Figure 1. Exhaust manifold glowing.

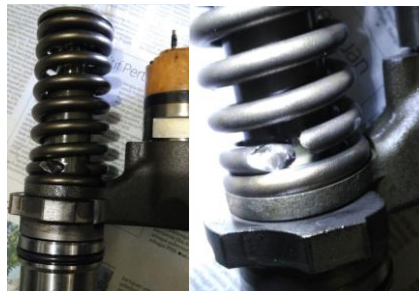
Figure 2. Spring injector broken.

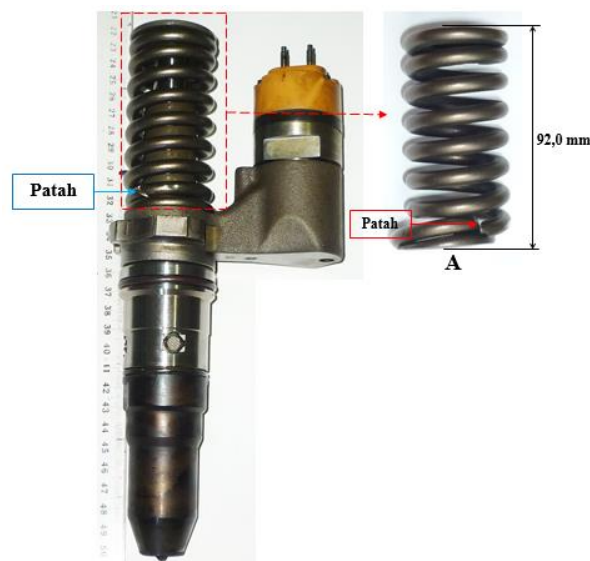
In a visual inspection of a spiral spring injector, A \emptyset wire diameter 7.0 mm and \emptyset 48 mm spring circumference has a broken first circle.

Figure 4. Macro photo injector.

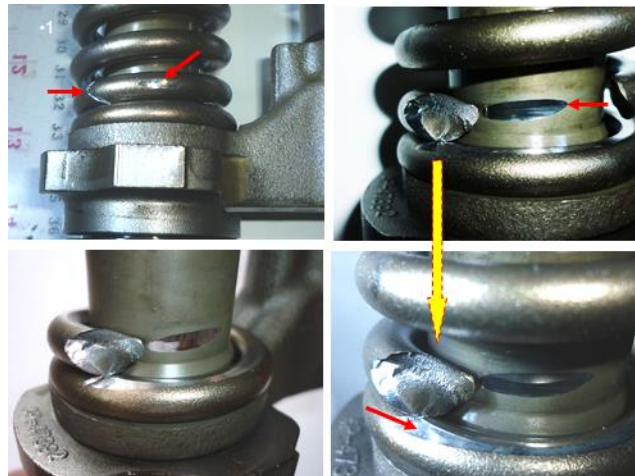
Photo macro image 8 on the injector spring the broken center point is a load bearing area and includes a fairly high center of stress concentration, it can be seen from the circumference area of the fracture there is a defect between the spring and spring wear.

Figure 5. Photo macro on the injector fracture surface.

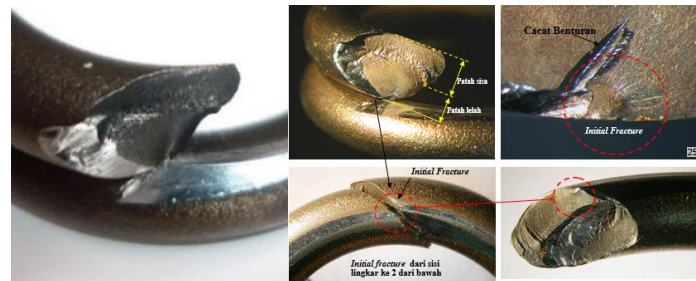
Figure 6 spiral spring circle 2 is the beginning of a fracture which first occurs the bending load thinning, while the shape of the fault has a 45° angle is a static fracture, while the 7 benchmark image on the injector spring fracture.

Figure 6. Early broken.

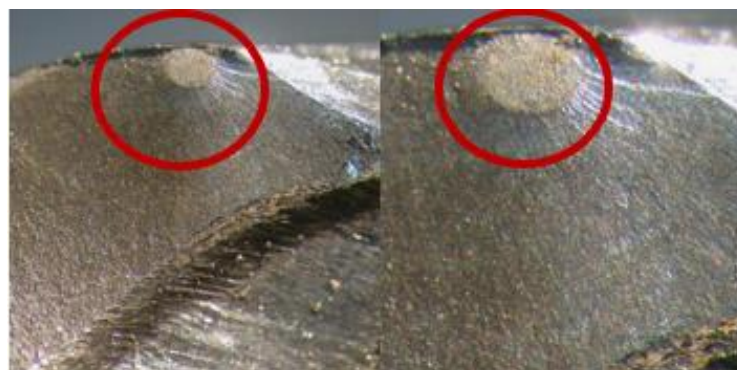
Metallographic testing Figure 7 describes a benchmark that occurs in a spiral spring, that a benchmark indication is a form of fatigue in the injector spring.

Figure 7. Benchmark injector spring fault.

- Metallographic results indicate a benchmark in the form of a fault, which indicates fatigue fracture (fatigue fracture). The initial form of initial fracture from the fracture of the injector

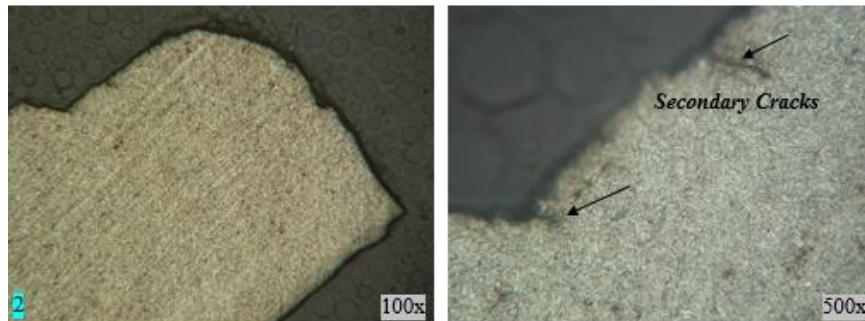
Figure 8 with 100x magnification and 500x there are secondary cracks due to dynamic loads. The secondary crack is caused when a break occurs and is not the cause of damage.

Figure 8. No.2 100x and 500x magnification.

- Secondary cracks on the fault surface as a result of overloads
- Chemical composition of injector spring with low alloy steel with Cr 1.03%, and Mo content of 0.753%, that spiral spring material is low alloy steel with high C content. The spring elasticity is quite high

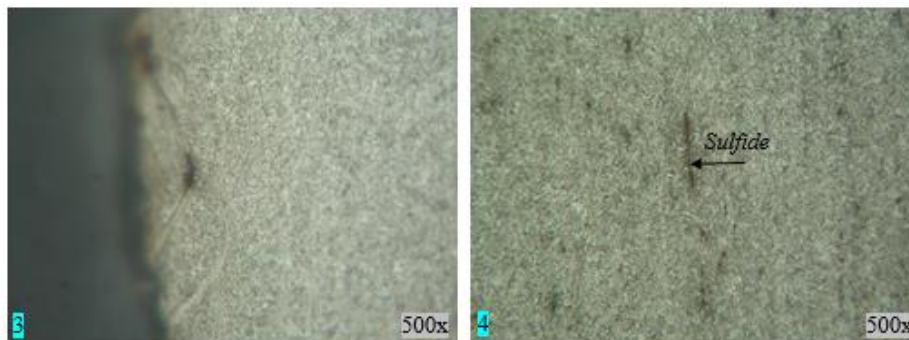
Figure 9. No. 3 in the edge area deformation of the structure due to the shot pining of the production process, the process will improve the performance of the spiral spring. While the number 4 microstructure is a marten site tamper and there is manganese sulphide. Where manganese sulphide is formed during the manufacturing process.

Figure 9. No 3 and No 4 Sulphide at helical compression spring.

- Sulphide content in spiral 1 microstructure is seen in a large amount of material, possibly making early fatigue
- The wear of cam lobes and roller lifter injectors will cause an abnormal height of the injector, and if each PM interval is found an abnormality of altitude will have an impact on the performance of the injector spring and can cause damage to the spring spiral injector broken.

Sulphide content in spiral spring microstructure is seen in the whole material quite a lot, possibly making the formation of early fatigue, with an indication of the beach mark in the form of a fatigue fracture in the injector spring.
