# Analysis of injector spring damage to determine maintenance management diesel engine at PLTD Ampenan

**Abstract.** The injector spring in cylinder #2 of a diesel engine in Ampenan PLTD which is operated by PT. X damaged. After visual inspection, a helical spring of the injector was broken. The spring broke in the lower part, in winding 2 of the spring. Before the damage was known, with a diesel load of 1100 kW, the exhaust manifold the cylinder #2 was glowing. Root cause analysis of the broken spiral spring was carried out by visual observation, metallography, and maintenance management analysis. Results indicated that the damaged of the broken injector spring based on visual observation of the helical spring was due to alternating bending loads. The fracture angle was at 45° indicated a bending load. Benchmark shows the beginning of the fault, followed by a static fracture. Metallographic and microstructure examination results found too many sulphides possibly making the formation of the onset of the fatigue. To minimize the damage, the sulphide amount of the spring must be reduced, and the spring injector material must be redesigned. Maintenance management must check every tim

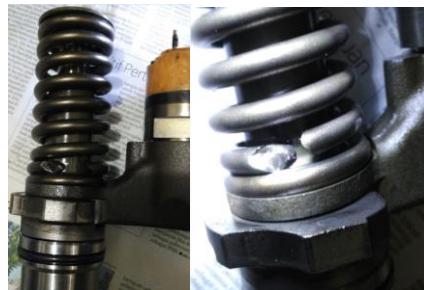
Salah satu Gen-Set mengalami kerusakan injector yang menyebabkan Gen-Set tidak bisa beroperasi dan setelah dilakukan pengecekan ditemukan pegas spiral injektor patah di bagian bawah yang ditampilkan gambar 1

Pada saat pegas spiral injektor patah tekanan di injektor turunnya lambat, dan durasi penyemprotan bahan bakar akan lebih lama, karena tekanan didalam injektor turunnya lambat, akibatnya akan terjadi *over fueling* dan glowing, sesuai dengan gambar 1

Gambar 1. Pegas Injektor Patah (Sumber: Dokumentasi kerusakan komponen).

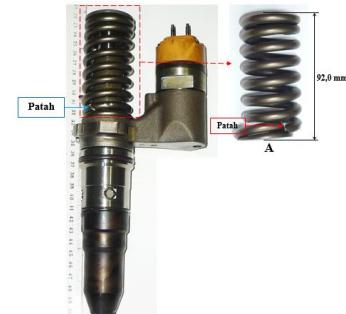
Gambar 4. Photo makro injektor

Dalam pemeriksaan visual pada injektor Pegas spiral A diameter kawat  $\varnothing$  7,0 mm dan  $\varnothing$  lingkar pegas 48 mm mengalami patah dilingkar pertama

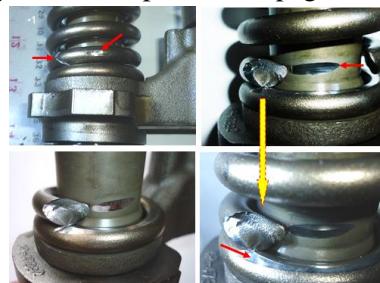
Photo makro gambar 8 pada pegas injektor titik pusat patah merupakan daerah tumpuan beban dan termasuk pusat konsentrasi tegangan yang cukup tinggi, hal tersebut dapat dilihat dari daerah lingkar lokasi patah adanya cacat himpitan antar pegas dan cacat aus pegas.

Gambar 5. Photo makro pada permukaan patahan injektor

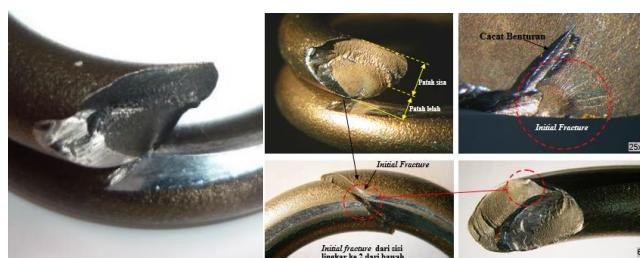
Gambar 6 pegas spiral lingkaran 2 merupakan awal patah yang terlebih dahulu terjadi penipisan beban bending, adapun bentuk patahan mempunyai sudut  $45^\circ$  merupakan patah statik, sedangkan gambar 7 beachmark pada patahan pegas injektor.

Gambar 6. Awal patah

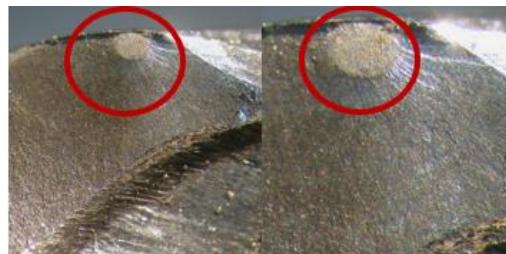
Gambar 7. Beachmark patahan pegas injektor

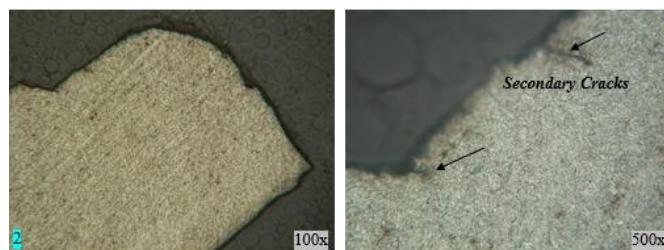
Gambar 8. No.2 Pembesaran 100x dan 500x

Gambar 14 dengan pembesaran 100x dan 500x terdapat *secondary cracks* akibat beban dinamis. Adapun *secondary crack* ini disebabkan saat terjadi patahan dan bukan penyebab kerusakan

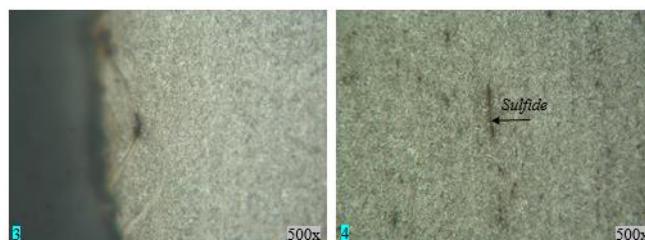
Gambar 15. no 3 di daerah tepi terjadi perubahan bentuk (*deformation*) struktur akibat shot pinning proses produksi, proses tersebut akan meningkatkan performa pegas spiral. Sedangkan no 4 struktur mikro berupa martensit tamper dan terdapat mangan sulfida

Gambar 9. No 3 & No 4 Sulfide at helical Spring

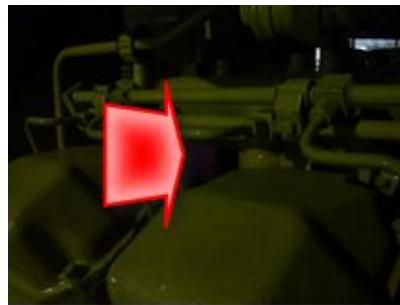
**Figure 1.** Exhaust manifold glowing

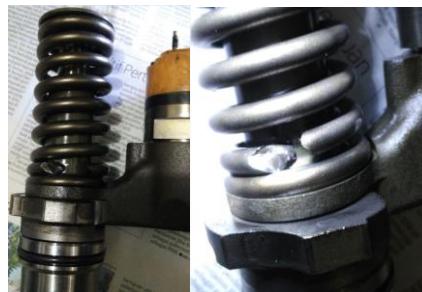
When the spiral spring of the injector breaks the pressure on the injector it drops slowly, and the duration of the fuel spraying will take longer, because the pressure inside the injector drops slowly, as a result, it will occur over fueling and glowing. On 30 minutes prior to the red or glowing damage to the exhaust manifold and then an emergency trip (normal stop) by the operator is explained in Figure 1. Damage to the injector that causes Gen-Set to be inoperable and after checking the injector helical spring is found Broken at the bottom shown in figure 1. After checking, it was found that a broken injector spring at the bottom as shown in Figure 2.

**Figure 2.** Spring injector broken

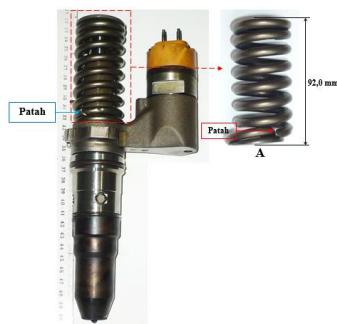
Figure 4. Macro photo injector

In a visual inspection of a spiral spring injector, A Ø wire diameter 7.0 mm and Ø 48 mm spring circumference has a broken first circle.

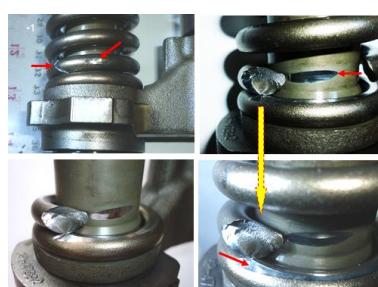
Photo macro image 8 on the injector spring the broken center point is a load bearing area and includes a fairly high center of stress concentration, it can be seen from the circumference area of the fracture there is a defect between the spring and spring wear.

**Figure 5.** Photo macro on the injector fracture surface

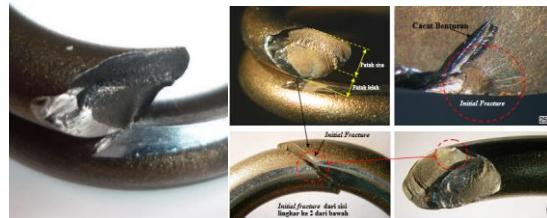
Figure 6 spiral spring circle 2 is the beginning of a fracture which first occurs the bending load thinning, while the shape of the fault has a 45° angle is a static fracture, while the 7 benchmark image on the injector spring fracture.

**Figure 6.** Early broken

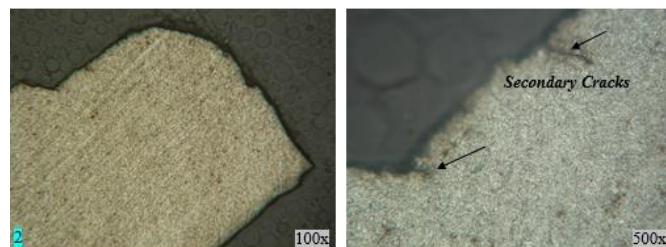
**Figure 8.** No.2 100x and 500x magnification

Figure 8 with 100x magnification and 500x there are secondary cracks due to dynamic loads. The secondary crack is caused when a break occurs and is not the cause of damage.

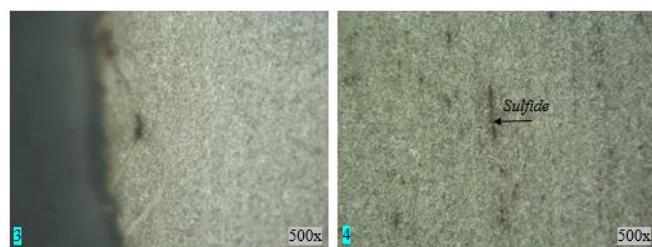
Figure 9. no. 3 in the edge area deformation of the structure due to the shot pinning of the production process, the process will improve the performance of the spiral spring. While the number 4 microstructure is a martensite tamper and there is manganese sulfide. Where manganese sulfide is formed during the manufacturing process.

**Figure 9.** No 3 & No 4 Sulfide at helical compression spring

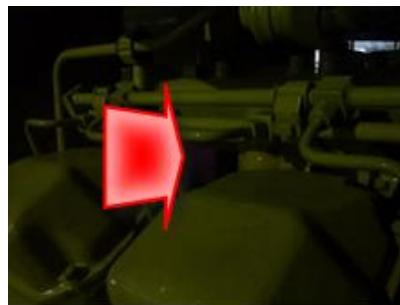
**Figure 1.** Exhaust manifold glowing.

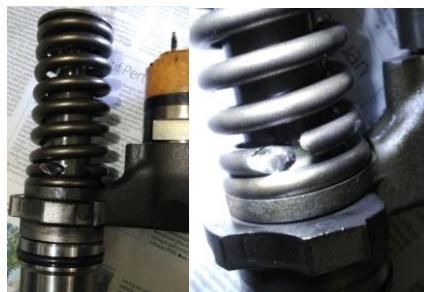
When the spiral spring of the injector breaks the pressure on the injector it drops slowly, and the duration of the fuel spraying will take longer, because the pressure inside the injector drops slowly, as a result, it will occur over fuelling and glowing. On 30 minutes prior to the red or glowing damage to the exhaust manifold and then an emergency trip (normal stop) by the operator is explained in Figure 1. Damage to the injector that causes Gen-Set to be inoperable and after checking the injector helical spring is found Broken at the bottom shown in figure 1. After checking, it was found that a broken injector spring at the bottom as shown in Figure 2.

**Figure 2.** Spring injector broken.

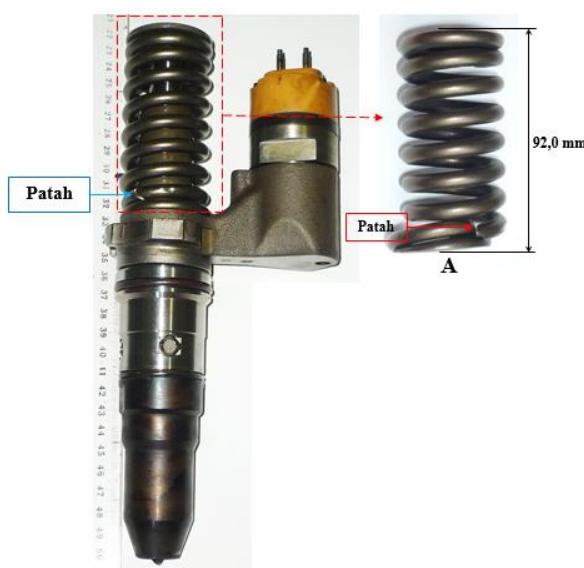
**Figure 4.** Macro photo injector.

In a visual inspection of a spiral spring injector, A Ø wire diameter 7.0 mm and Ø 48 mm spring circumference has a broken first circle.

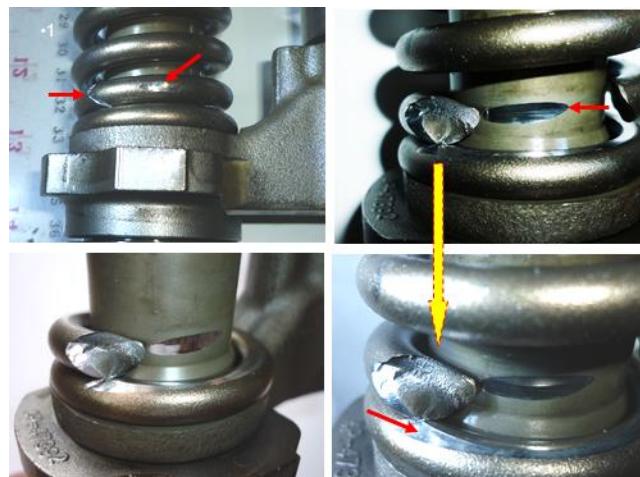
Photo macro image 8 on the injector spring the broken center point is a load bearing area and includes a fairly high center of stress concentration, it can be seen from the circumference area of the fracture there is a defect between the spring and spring wear.

**Figure 5.** Photo macro on the injector fracture surface.

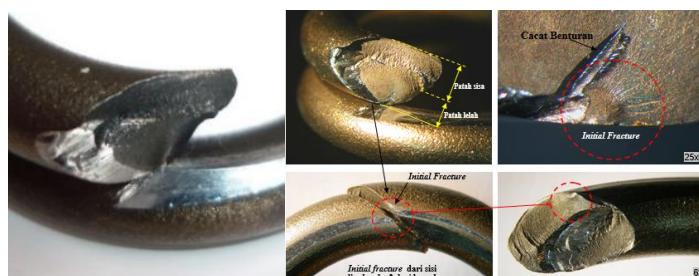
Figure 6 spiral spring circle 2 is the beginning of a fracture which first occurs the bending load thinning, while the shape of the fault has a  $45^\circ$  angle is a static fracture, while the 7 benchmark image on the injector spring fracture.

**Figure 6.** Early broken.

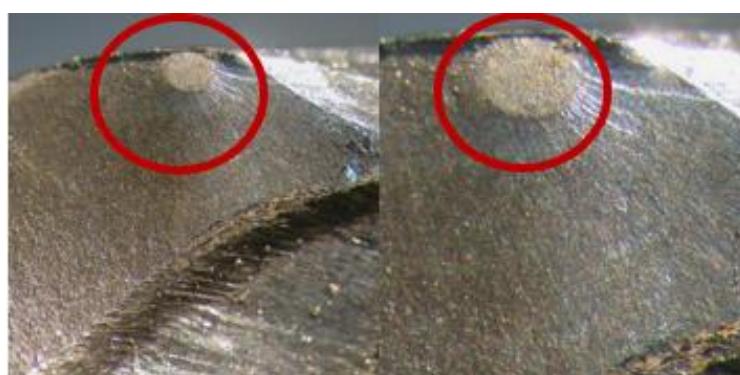
Metallographic testing Figure 7 describes a benchmark that occurs in a spiral spring, that a benchmark indication is a form of fatigue in the injector spring.

**Figure 7.** Benchmark injector spring fault.

- Metallographic results indicate a benchmark in the form of a fault, which indicates fatigue fracture (fatigue fracture). The initial form of initial fracture from the fracture of the injector

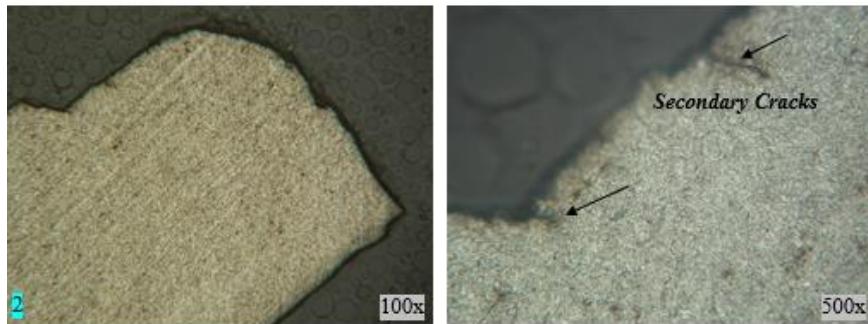
**Figure 8.** No.2 100x and 500x magnification.

Figure 8 with 100x magnification and 500x there are secondary cracks due to dynamic loads. The secondary crack is caused when a break occurs and is not the cause of damage.

- Secondary cracks on the fault surface as a result of overloads
- Chemical composition of injector spring with low alloy steel with Cr 1.03%, and Mo content of 0.753%, that spiral spring material is low alloy steel with high C content. The spring elasticity is quite high

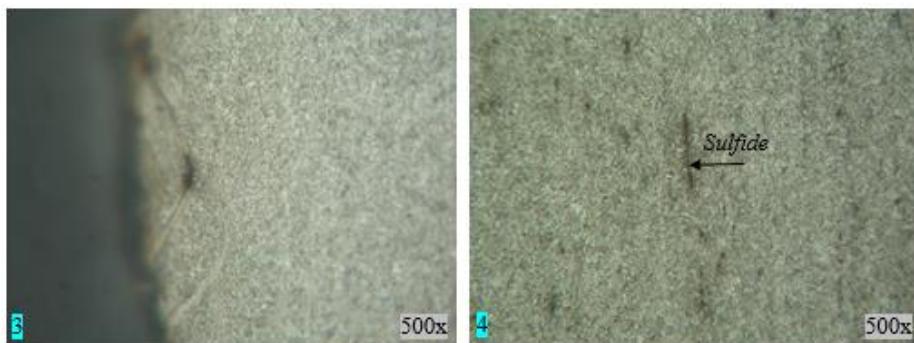
Figure 9. No. 3 in the edge area deformation of the structure due to the shot pinning of the production process, the process will improve the performance of the spiral spring. While the number 4 microstructure is a marten site tamper and there is manganese sulphide. Where manganese sulphide is formed during the manufacturing process.

**Figure 9.** No 3 and No 4 Sulphide at helical compression spring.

Sulphide content in spiral spring microstructure is seen in the whole material quite a lot, possibly making the formation of early fatigue, with an indication of the beach mark in the form of a fatigue fracture in the injector spring.

- Sulphide content in spiral 1 microstructure is seen in a large amount of material, possibly making early fatigue
- The wear of cam lobes and roller lifter injectors will cause an abnormal height of the injector, and if each PM interval is found an abnormality of altitude will have an impact on the performance of the injector spring and can cause damage to the spring spiral injector broken.
