Analysis of SOS Results for Engine Lubricants Contaminated by the Fuel in The 3516 TA Diesel Engine Generator Set

Wilurso(1), Aswin Domodite(1), Hilman Sholih (1), Mujiarto (2)

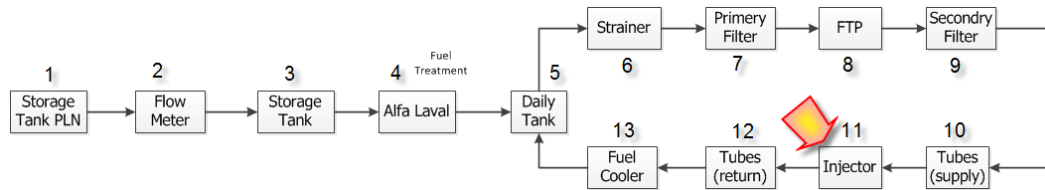
Figure 1. Position of damage to the injector

To meet stringent standards, the Common Rail fuel injection system has been implemented, which increases fuel injection pressure and introduces multi-stage dosing. The cost of repairs is very high because of sophisticated parts and technology and to reduce the cost of repairs [6]. In figure 1, the damage to the injector is explained [7].

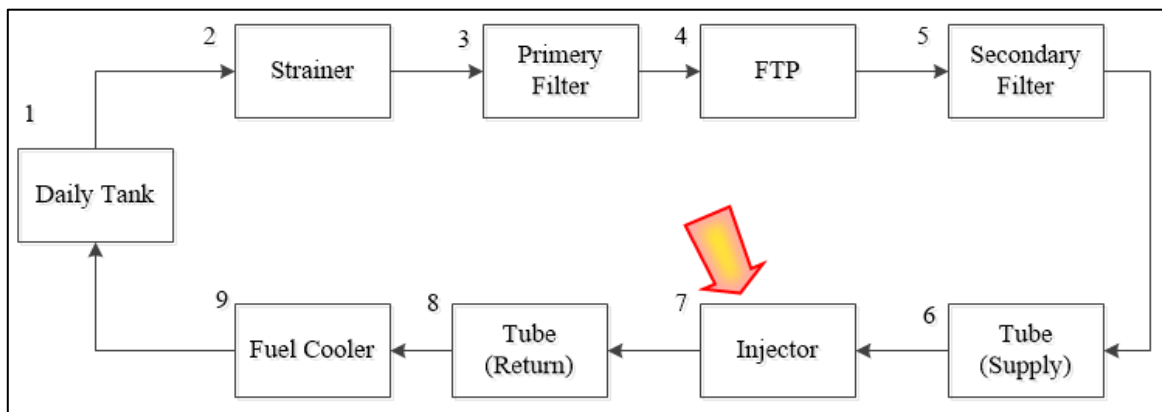
Figure 1. Position of damage to the injector

In the explanation in Figure 1, 1) Daily tank functions to collect fuel after leaving the engine, 2) the strainer functions to filter large particles before entering the fuel system. 3) Primary filter functions to filter small particles in micron size, 4) Fuel transfer pump to transfer to the fuel system, 5) Secondary filter functions to filter particles under 5 microns, 6) tube (supply) to deliver fuel to the injector, 7) The injector functions to inject fuel into the fuel chamber, 8) Tube (return) distributes the material after the injector, 9) The fuel cooler functions to cool the fuel after the injection system, the damage that occurs at no. 7 (injector).

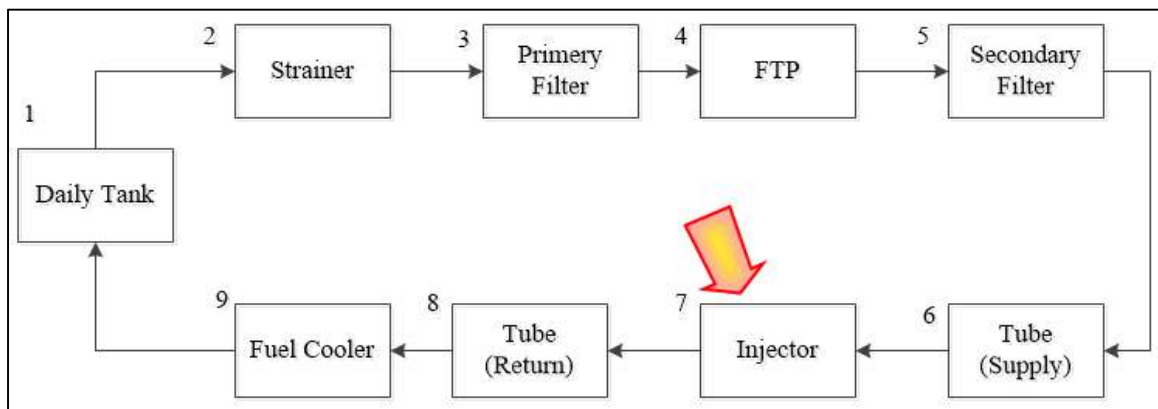
Figure 1. Position of damage to the injector

In the explanation in Figure 1, 1) Daily tank functions to collect fuel after leaving the engine, 2) the strainer functions to filter large particles before entering the fuel system. 3) Primary filter functions to filter small particles in micron size, 4) Fuel transfer pump to transfer to the fuel system, 5) Secondary filter functions to filter particles under 5 microns, 6) tube (supply) to deliver fuel to the injector, 7) The injector functions to inject fuel into the fuel chamber, 8) Tube (return) distributes the material after the injector, 9) The fuel cooler functions to cool the fuel after the injection system, the damage that occurs at no. 7 (injector).
