# Analysis of injector spring damage to determine maintenance management diesel engine at PLTD Ampenan

**Abstract.** The injector spring in cylinder #2 of a diesel engine in Ampenan PLTD which is operated by PT. X damaged. After visual inspection, a helical spring of the injector was broken. The spring broke in the lower part, in winding 2 of the spring. Before the damage was known, with a diesel load of 1100 kW, the exhaust manifold the cylinder #2 was glowing. Root cause analysis of the broken spiral spring was carried out by visual observation, metallography, and maintenance management analysis. Results indicated that the damaged of the broken injector spring based on visual observation of the helical spring was due to alternating bending loads. The fracture angle was at 45° indicated a bending load. Benchmark shows the beginning of the fault, followed by a static fracture. Metallographic and microstructure examination results found too many sulphides possibly making the formation of the onset of the fatigue. To minimize the damage, the sulphide amount of the spring must be reduced, and the spring injector material must be redesigned. Maintenance management must check every tim

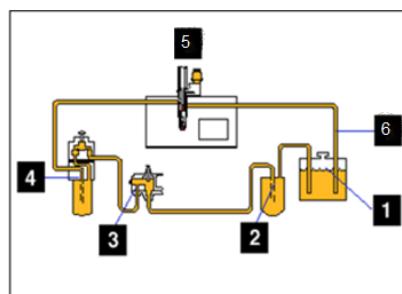
Gambar 2. Fuel Line Diesel Engine (Sumber: Dasar-Dasar Diesel Engine-Caterpillar)

Sistem eletronik unit injection (EUI) menggunakan beberapa komponen yang sama seperti yang dipakai oleh sistem *pump* dan *line*. Sistem EUI menggunakan, 1. *Fuel tank*, 2. *Primary fuel filter*, 3. *Fuel transfer pump*, 4. *Secondary fuel filter*, 5. *Injector*, 6. *Return line*, yang dijelaskan pada gambar 3.

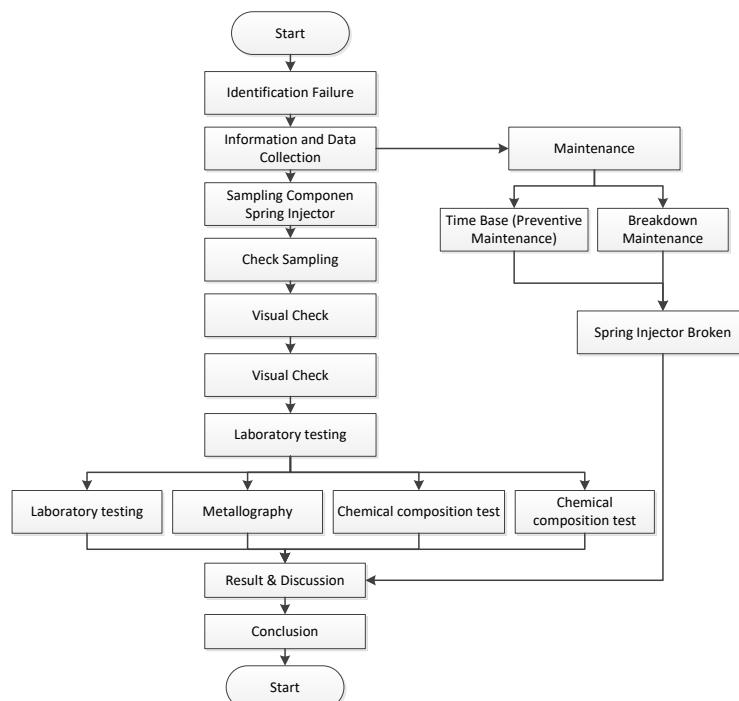
Gambar 3. Metode penelitian

1. Melakukan observasi lapangan terhadap kerusakan komponen injektor.
2. Melakukan pemeriksaan visual pegas injektor patah, terhadap operasional.
3. Melakukan pengambilan sampel uji pada pegas injektor.
4. Pemeriksaan laboratorium fractografi pada sampel uji untuk mengetahui kerusakan pegas injektor yang patah.
5. Pemeriksaan metalografi pada sampel uji untuk mengetahui mikrostruktur pada pegas injektor.
6. Pemeriksaan uji kekerasan sampel uji terhadap kualitas material.
7. Pemeriksaan komposisi kimia terhadap kualitas material.
8. Pemeriksaan terhadap laju korosi pada material pegas injektor.
9. Pemeriksaan data pemeliharaan *preventive maintenance* dan *breakdown maintenance*.

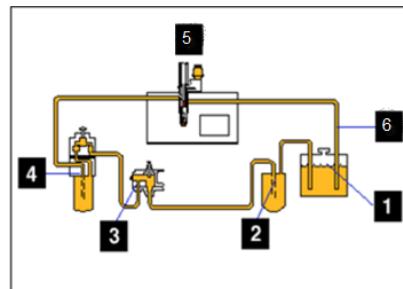
**Figure 3.** Fuel line diesel engine

The electronic unit injection (EUI) system uses several of the same components as those used by the pump and line systems. The EUI system uses 1. Fuel tank, 2. Primary fuel filter, 3. Fuel transfer pump, 4. Secondary fuel filter, 5. Injector, 6. Return line, which is described in figure 3.

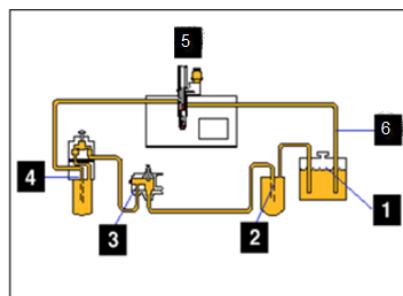
**Figure 3.** Fuel line diesel engine.

The electronic unit injection (EUI) system uses several of the same components as those used by the pump and line systems. The EUI system uses 1. Fuel tank, 2. Primary fuel filter, 3. Fuel transfer pump, 4. Secondary fuel filter, 5. Injector, 6. Return line, which is described in figure 3.
